# Best Practice Bulletin #5

## Maintaining sight of buried services

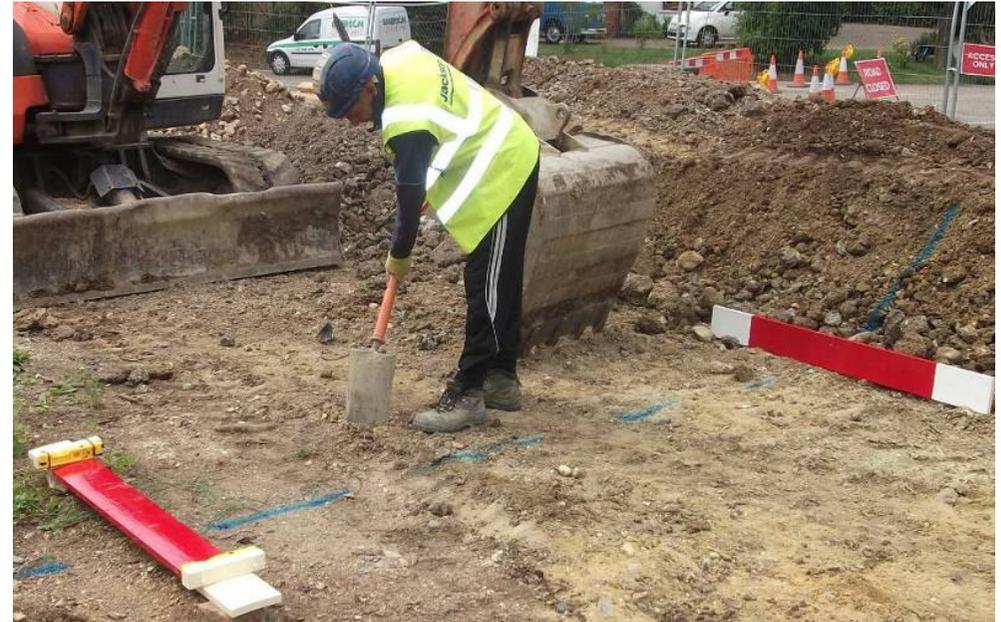
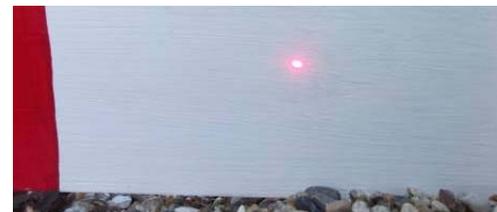
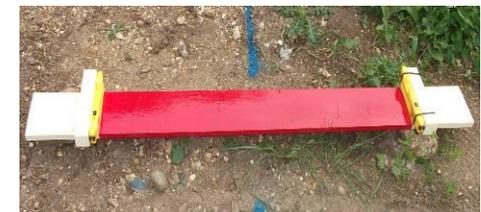
The solution is based on a method adopted by a fellow NCF2 contractor using a laser to solve a problem relating to batter control. To delineate the extent of the mechanical dig exclusion zone, two lasers are used.

The banksman can easily determine the line by placing his shovel in front of one of the lasers. The alignment and effectiveness of the lasers can be checked by looking for the laser dots on a board established on the opposite side of the dig.

The trial at Steeple Bumpsead FAS showed that the solution was suitable for situations where there are only a few services, and the line of the services is known to be straight. A very simple and relatively cheap solution – materials costing less than £50!
